Committee of the Whole Report For the Meeting of October 8, 2020

To: Committee of the Whole **Date:** October 1, 2020
From: Karen Hoese, Director, Sustainable Planning and Community Development
Subject: Report on the Potential Heritage Designation of 1623-1625 Bank Street

BANK STREET SCHOOL CONDITION ASSESSMENT REPORT

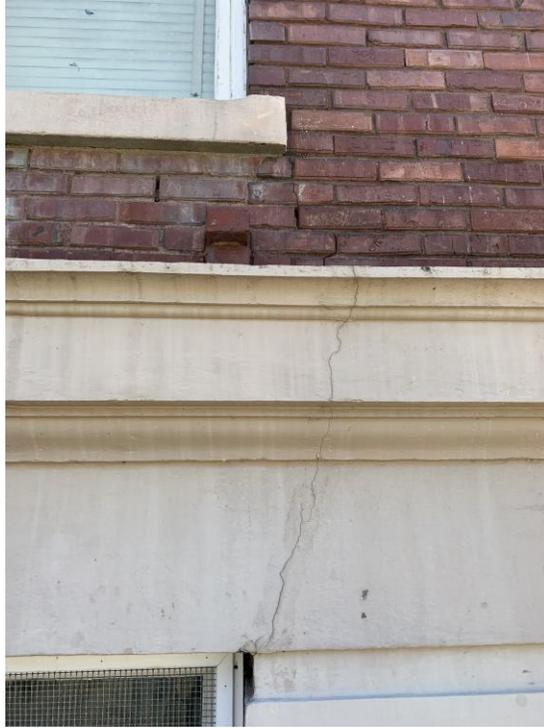
- Settlement of the foundation is causing minor spider cracking in mortar joints of the masonry walls.
- Interior finishes and most interior components are past their useful service life.

Crack in Brickwork

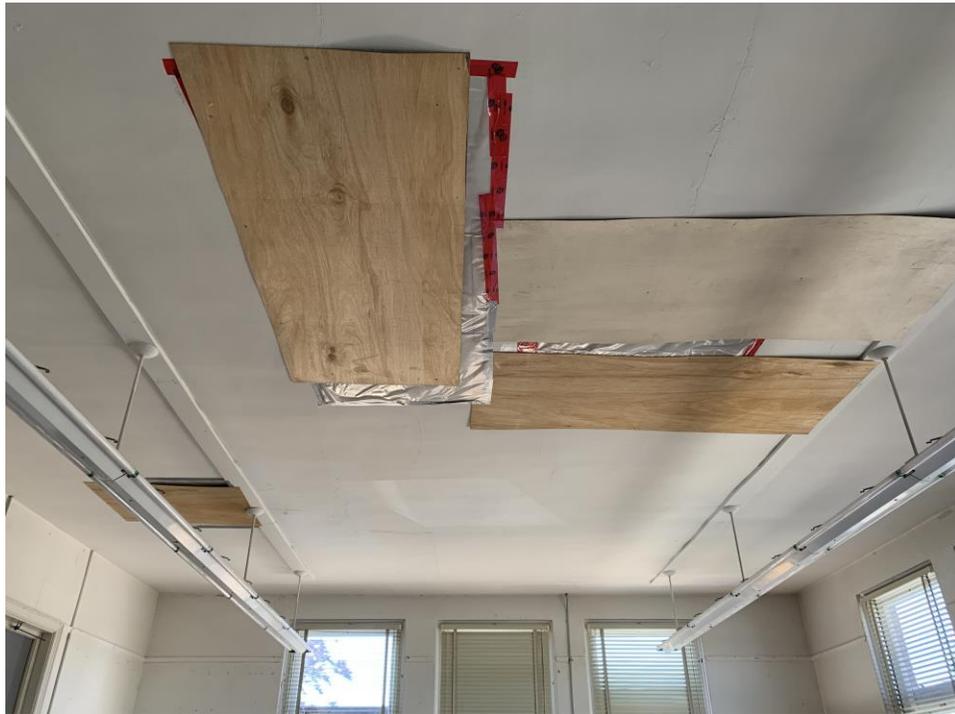
- The slate roof requires replacement and has leaked in several location over time.
- Settlement and fractures are present in the concrete foundation around the perimeter of the building.

Ceiling patches
